# **INDOOR AIR QUALITY ASSESSMENT**

**Lake Street School  
17 Lake Street  
Spencer, MA 01562**

Prepared by:  
Massachusetts Department of Public Health  
Center for Environmental Health  
Emergency Response/Indoor Air Quality Program  
April 2006

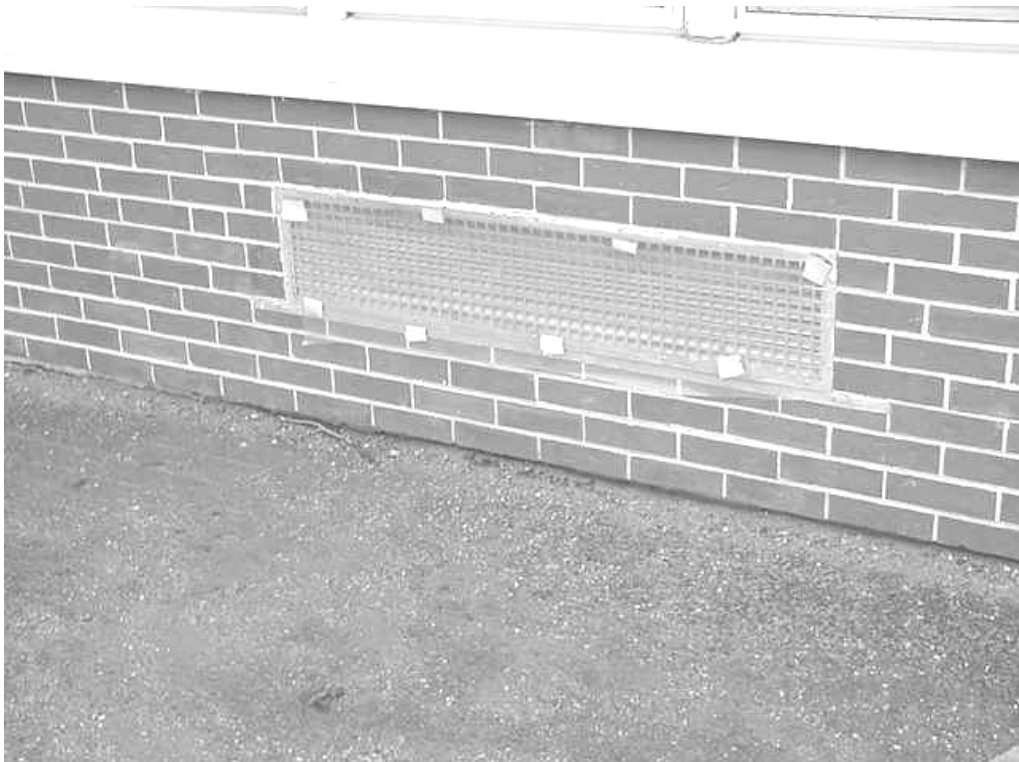
**Picture 3**

Univents were operating in the majority of areas surveyed; however, the air intakes for classroom 16 and Mrs. Sprow's room were sealed with plastic and duct tape (Picture 3). The air intakes were reportedly sealed to prevent freezing of pipes, which had occurred several times in the past year resulting in water damage in these areas. This condition can be the result of the malfunctioning of univent airflow control louvers,

**Univent Air Intake, Note this Intake was Sealed with Plastic and Duct Tape to Prevent Freezing of Pipes**

1. Contact a HVAC engineering firm to investigate and provide recommendations regarding the freezing of pipes and sealing of univent fresh air intakes in problem areas. In some cases the MDPH has recommended installation of a sheet metal awning that can direct cold air/wind away from intake vents (Picture 28).
2. Ensure univent air intakes are unsealed after the heating season to provide fresh air as designed.
3. Survey classroom univents to ascertain function and determine whether an adequate air supply exists for each room. Consider consulting a heating, ventilation and air conditioning (HVAC) engineer concerning the calibration of univent fresh air control dampers throughout the school.

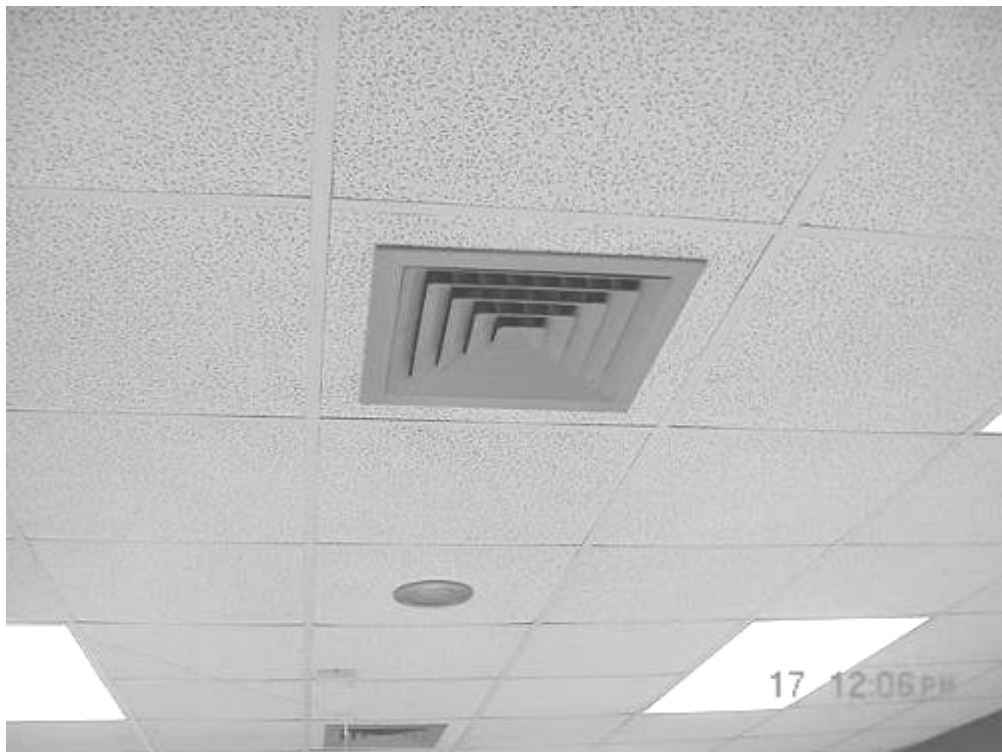
**Picture 4**

**Ceiling-Mounted Supply Vents**

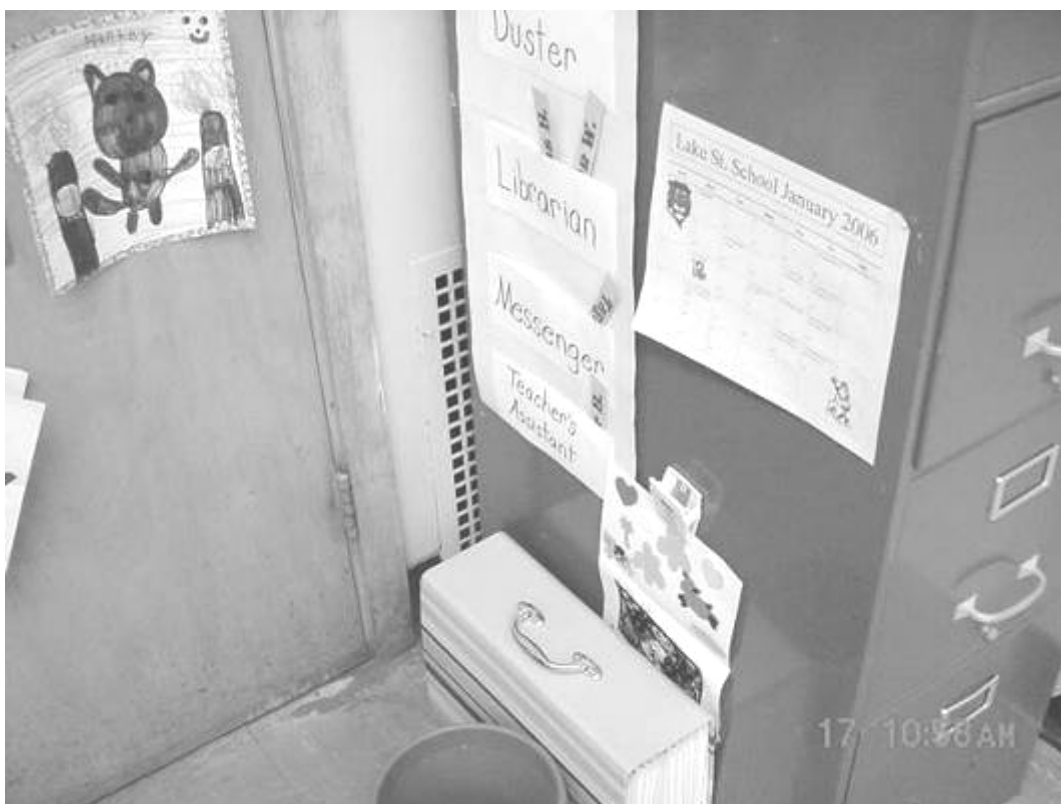
**Picture 5**

The mechanical exhaust ventilation system consists of wall-mounted vents (Pictures 5) or vents installed in the ceilings of coat closets (Picture 6). Vents are ducted to rooftop motors. Exhaust vents were deactivated during the assessment. During the assessment, the school custodian reactivated exhaust ventilation in some areas; however, exhaust ventilation in other areas was not functioning due to a faulty motor. Exhaust vents were also found obstructed by furniture, boxes and other items during the assessment (Picture 5). In order for exhaust vents to function as designed, they must be activated and free of obstructions. Without functioning exhaust ventilation, odors and other environmental pollutants can build up due to lack of air exchange. It is also important to note that the location of some exhaust vents can limit exhaust efficiency. In some classrooms, exhaust vents are located near hallway doors (Picture 7). When classroom doors are open, exhaust vents will tend to draw air from both the hallway and the classroom. The open hallway door reduces the effectiveness of the exhaust vent to remove common environmental pollutants from the classroom.

**Wall-Mounted Exhaust Vent (1950's Wing) Obstructed by File Cabinet**

6. Remove all blockages from univents and exhaust vents. Remove cardboard from exhaust vent in 2<sup>nd</sup> floor book room and restore local exhaust ventilation above photocopier.

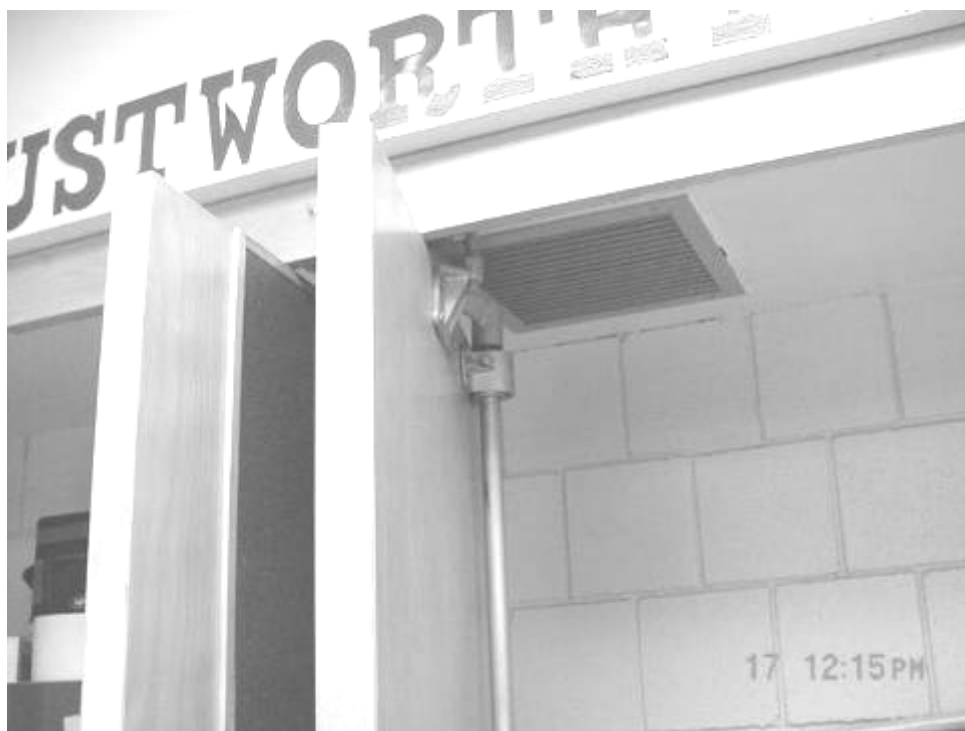
**Picture 6**

**Coat Closet Exhaust Vent in 1970's Wing**

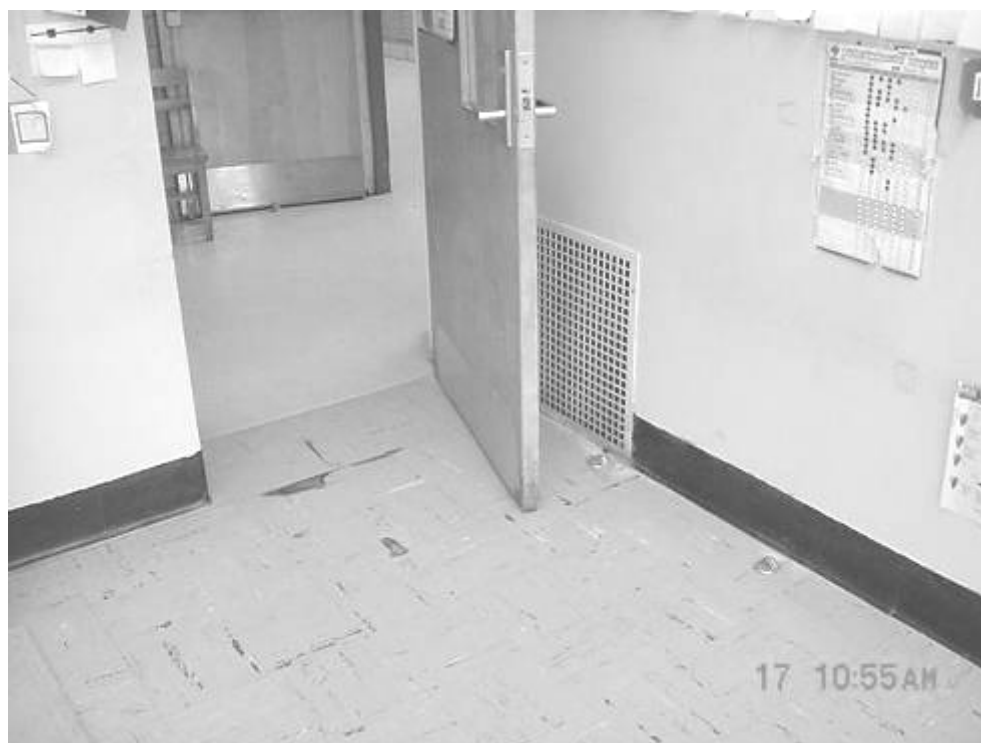
**Picture 7**

**Wall-Mounted Exhaust Vent (1950's Wing) behind Open Hallway Door**

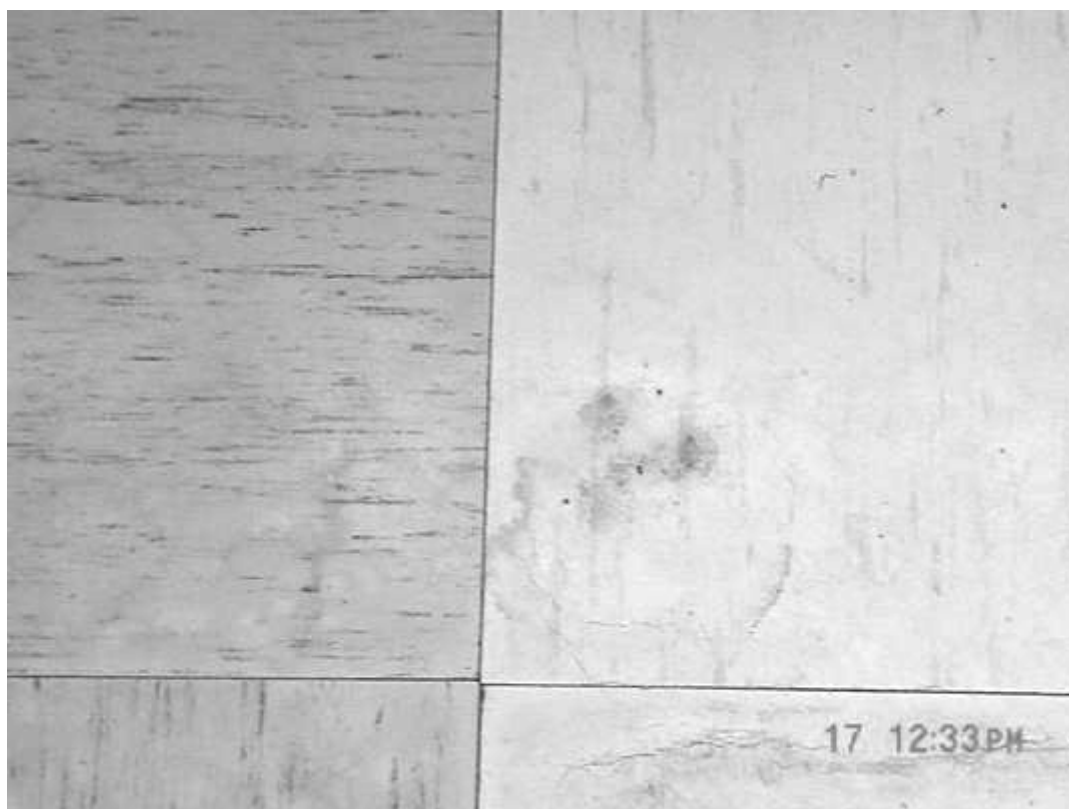
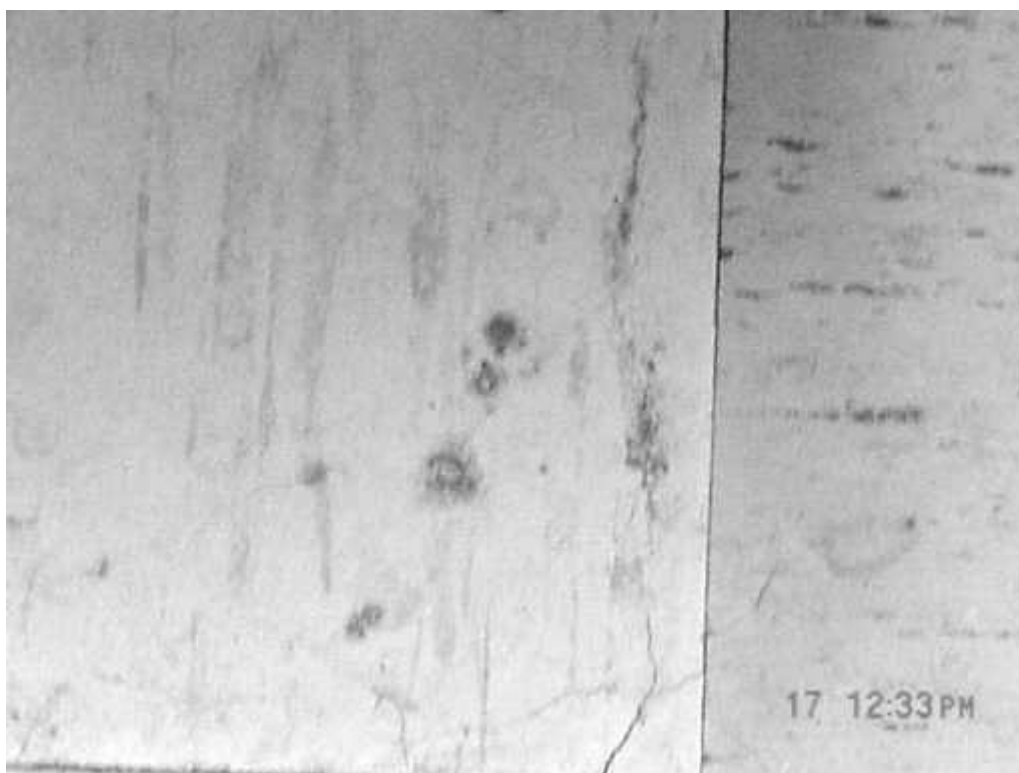
A characteristic staining of floor tiles associated with chronic moisture was observed in several classrooms in the 1977 wing (Pictures 8 and 9). MDPH staff examined stained floor tiles in affected classrooms and recommended that they be cleaned and disinfected as a temporary measure. School officials could not confirm whether a vapor retarder had been installed to prevent moisture seepage from sub-slab areas. Such a barrier would have been installed when the addition was constructed. Without a vapor retarder, moisture can be drawn upward through the concrete slab by hydrostatic pressure and/or capillary action. Moisture can dissolve alkalis in concrete to form a solution that can raise pH levels beneath flooring, which leads to the breakdown of adhesives (Donnelly, 2005). Another potential source of moisture was observed outside the building in this area. Water pooling was observed directly outside classroom 27 (Picture 10), which had the most prominently stained floor tiles. A breach was observed between the brick and concrete foundation in the area, which can serve as a pathway for moisture beneath tiles (Picture 11).

**Staining of Floor Tiles in Classroom 27, 1970's Wing**

13. Consider removing floor tiles in areas of chronic water damage (e.g., classroom 27) to determine if visible moisture and/or microbial growth are present. If so, the removal of all affected tiles followed by cleaning with an appropriate antimicrobial agent may be necessary.

14. Consider contacting a reputable flooring contractor to remove/replace old tiles and mastic. Slab should be completely cleaned and sealed with a proper sealant and/or vapor barrier.

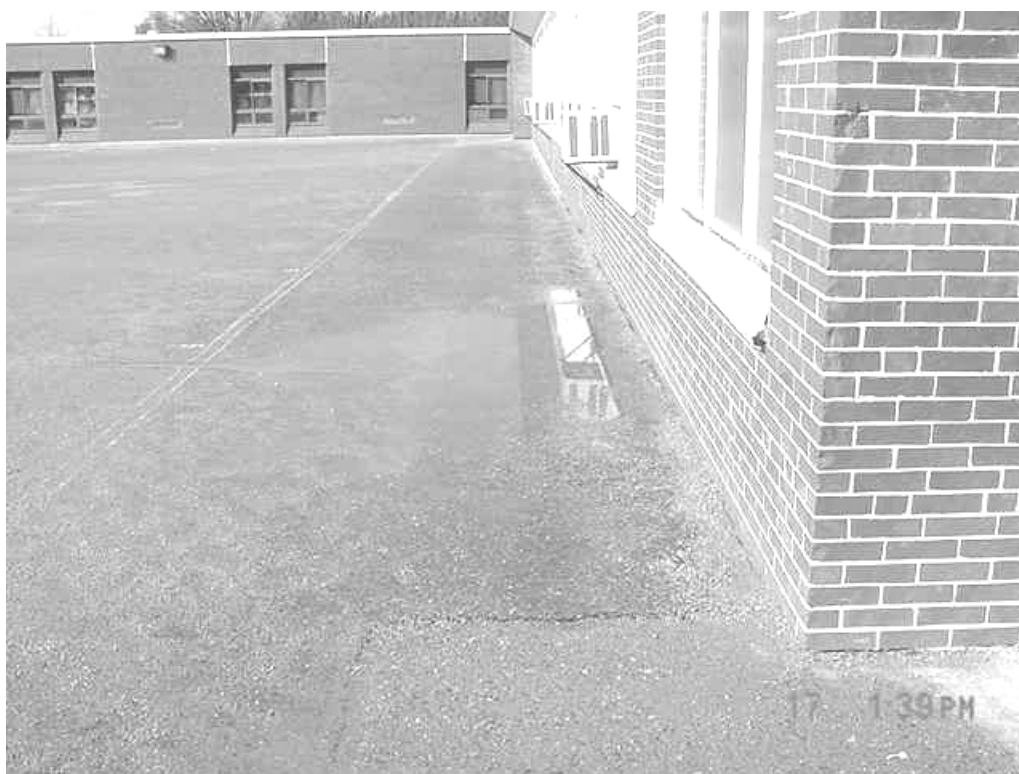
**Picture 10**

**Water Pooling outside of Classroom 27, 1970's Wing**

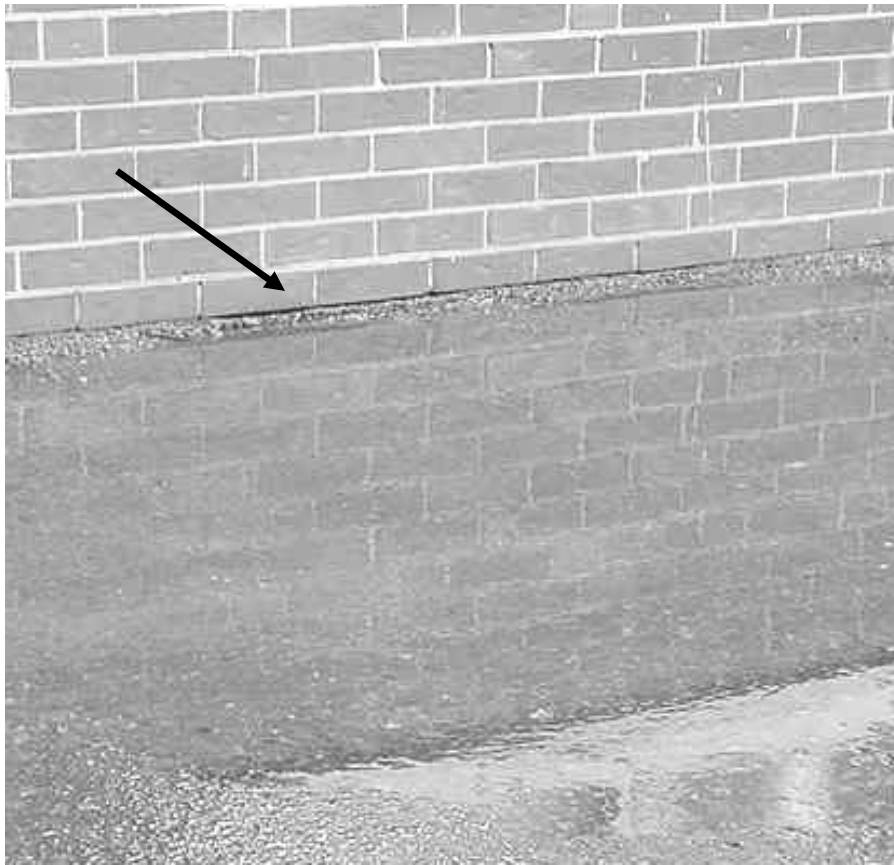
**Picture 11**

**Breach between Brick and Foundation in Area of Water Pooling Outside Classroom 27**

12. Contact a masonry firm or general contractor to repair breaches in exterior wall outside classroom 27 to prevent water penetration, drafts and pest entry.

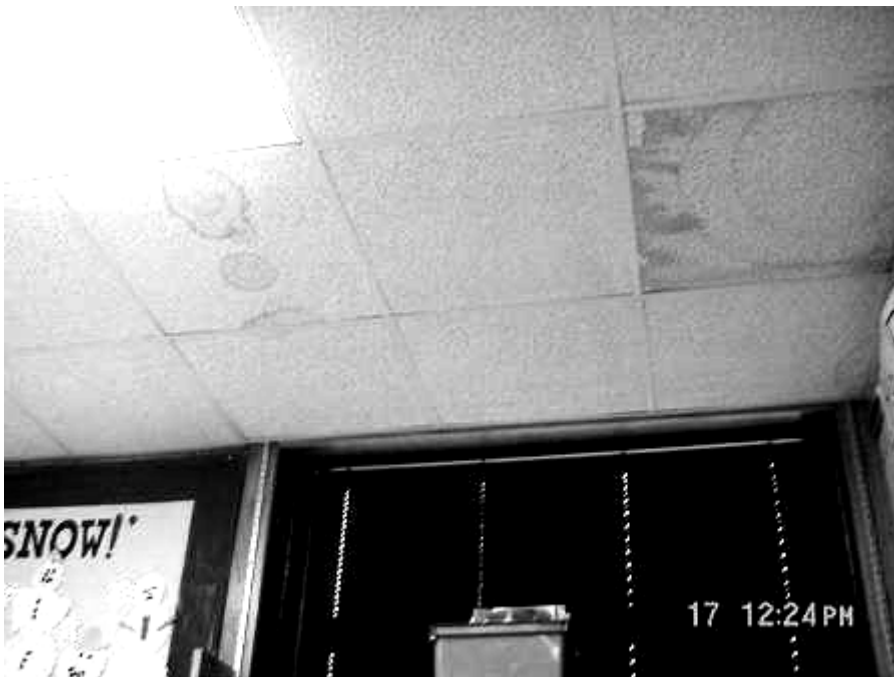
**Picture 12**

Several areas had water damaged ceiling tiles (Picture 12), which can indicate leaks from the roof or plumbing system. Water damaged ceiling tiles and other porous building materials can provide a source for mold growth and should be replaced after a moisture source or leak is discovered and repaired.

**Water Damaged Ceiling Tiles**

17. Ensure any roof/plumbing leaks are repaired. Replace water-damaged ceiling tiles. Examine the area above and around these areas for mold growth. Disinfect areas of water leaks with an appropriate antimicrobial.

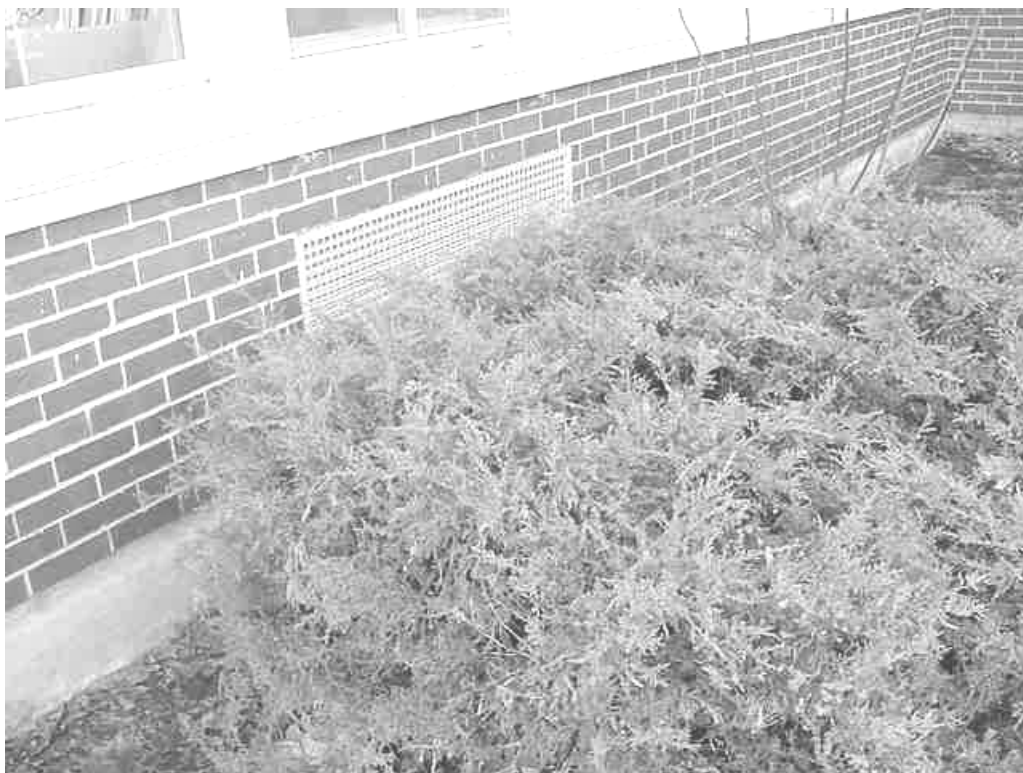
**Picture 13**

Plants were noted in close proximity to univent air intakes (Picture 13) and diffusers. Plants can be a source of pollen and mold, which can be respiratory irritants for some individuals. Plants should be properly maintained and equipped with drip pans. Plants should also be located away from ventilation sources to prevent the entrainment and/or aerosolization of dirt, pollen or mold.

**Shrubbery in Close Proximity to Univent Air Intake**

19. Move plants away from univents in classrooms and away from air intakes on the exterior of the building (Picture 13). Ensure all plants are equipped with drip pans. Examine drip pans for mold growth and disinfect areas of water leaks with an appropriate antimicrobial where necessary.

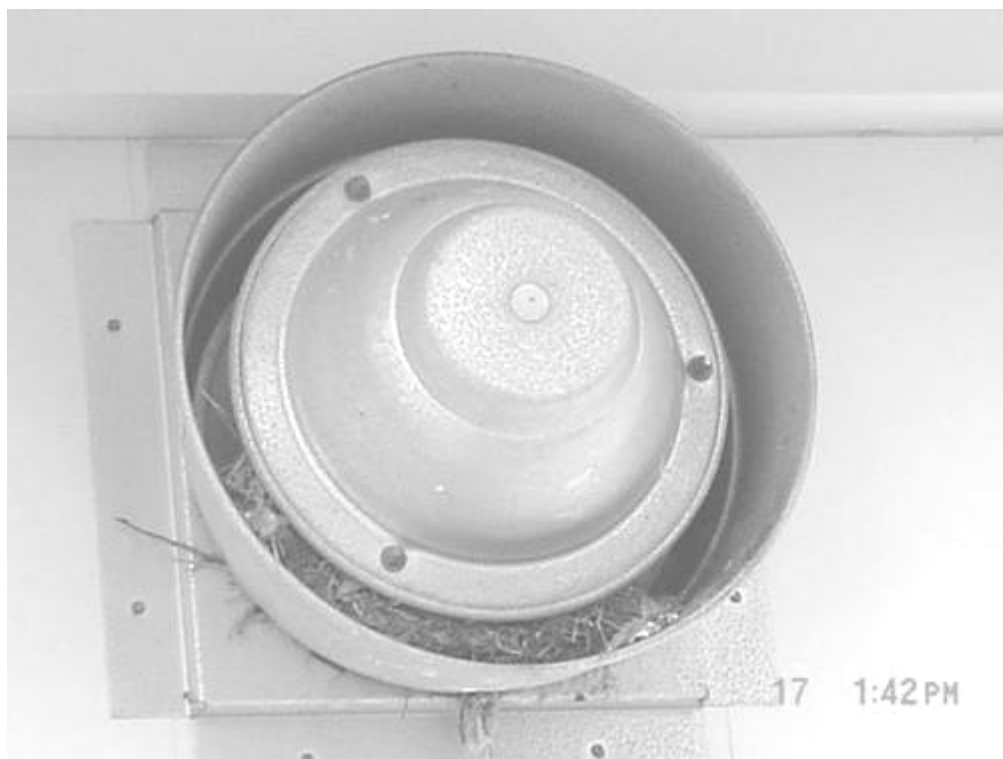
**Picture 14**

A bird's nest was observed in the exterior housing of a local exhaust vent located in the art room (Picture 14). At the time of the assessment, CEH staff recommended removing the nest and disinfecting the vent louvers with an anti-microbial agent. CEH staff also recommended sealing the vent on the inside with plastic and duct tape prior to cleaning to prevent infiltration of bacteria, mold or associated odors into the art room. Birds can be a source of disease, and bird wastes and feathers can contain mold, which can be irritating to the respiratory system. CEH staff did not observe obvious signs of a bird roosting inside the building nor were such signs reported by occupants.

**Bird Nesting Materials in Local Exhaust Fan Housing (Art Room)**

16. Ensure bird's nest is removed from art room exhaust vent (Picture 14). Inspect to ensure surfaces are free of nesting materials and bird wastes. Clean and disinfect with an appropriate antimicrobial where necessary. Consider installing wire mesh or seal permanently to prevent further roosting.

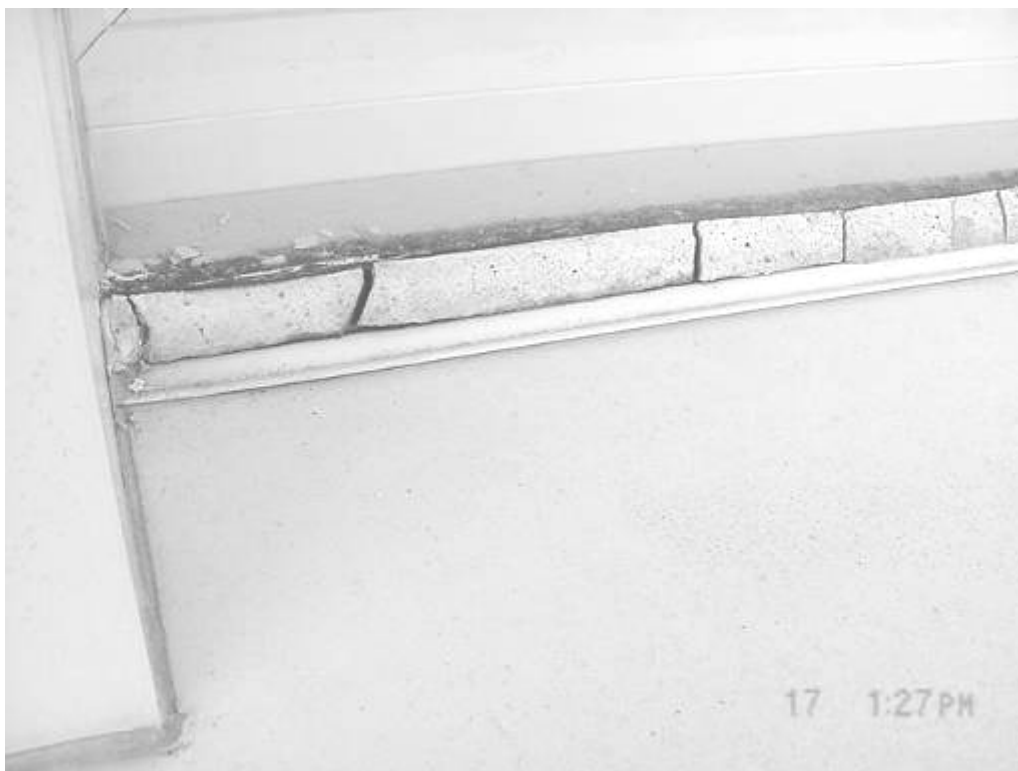
**Picture 15**

Finally, exterior caulking around windows was missing/damaged in many areas (Pictures 15). Some of the panes were loose or broken and drafts were evident in several areas. Missing caulking and/or loose fitting window panes can make it difficult to control temperature and allow a means for water penetration into the building, leading to comfort complaints and/or water damage and subsequent microbial growth.

**Damaged Exterior Caulking around Window**

18. Repair/replace broken windows; re-seal loose window frames to prevent drafts and water penetration.

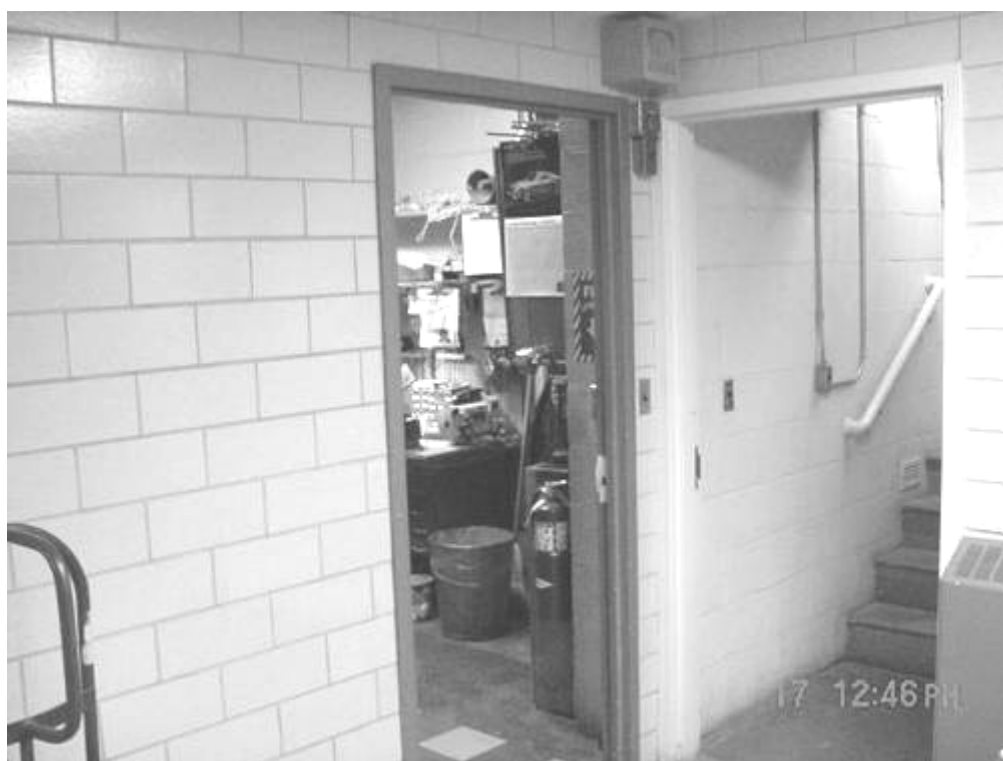
**Picture 16**

**Boiler Room Door Propped Open during the Assessment**

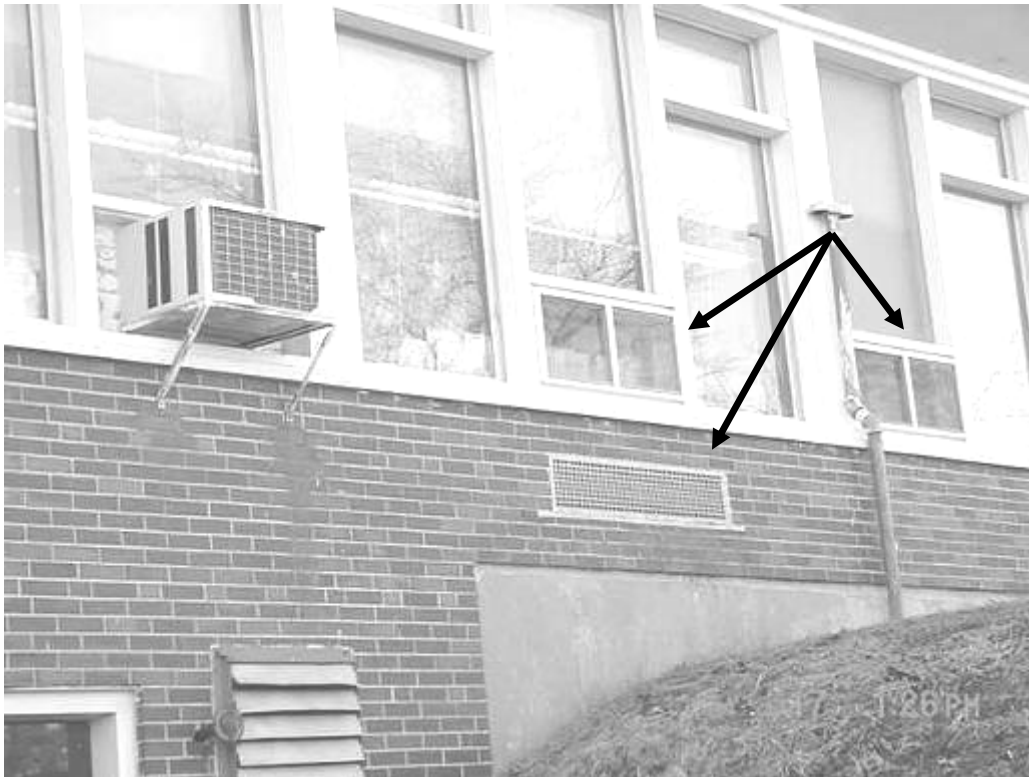
**Picture 17**

School officials reported periodic odors during fuel delivery. The vent pipe for the fuel tank is located in close proximity to classroom windows and univent air intakes (Picture 17). Fuel delivery during school hours can result in fuel odors and/or vehicle exhaust emissions penetrating into classrooms adjacent to the oil tank through open windows and/or the mechanical ventilation system. In turn, this can provide opportunities for exposure to products of combustion, including carbon monoxide. M.G.L. chapter 90 section 16A prohibits the unnecessary operation of the engine of a motor vehicle for a foreseeable time in excess of five minutes (MGL, 1996).

**Proximity of Vent Pipe for Fuel Tank (on Right) to Classroom Windows and Univent Air Intake**

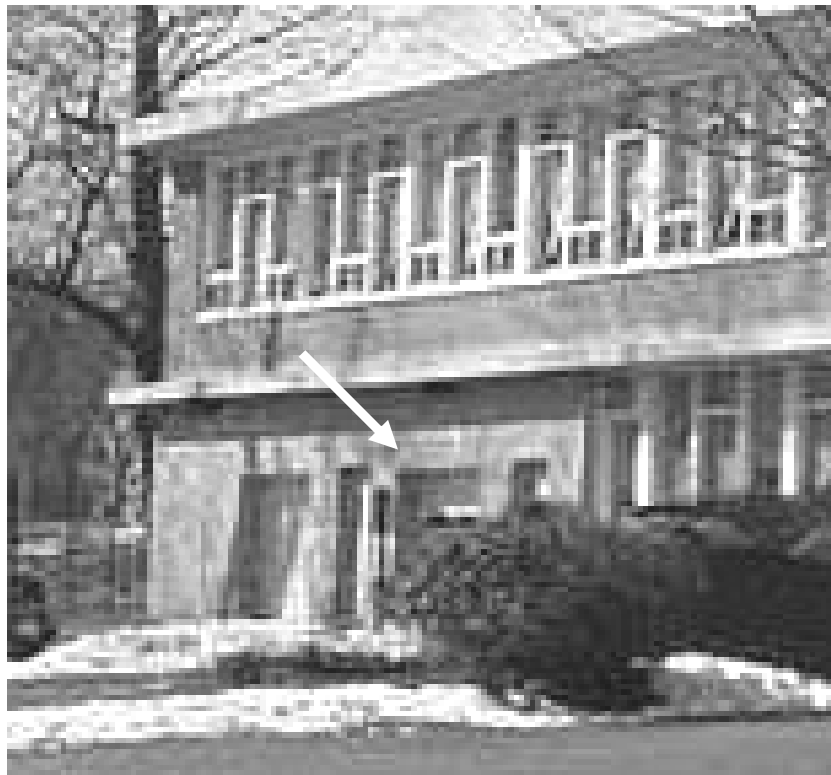
**Picture 18**

**Exterior Garage Door for Storage Room**

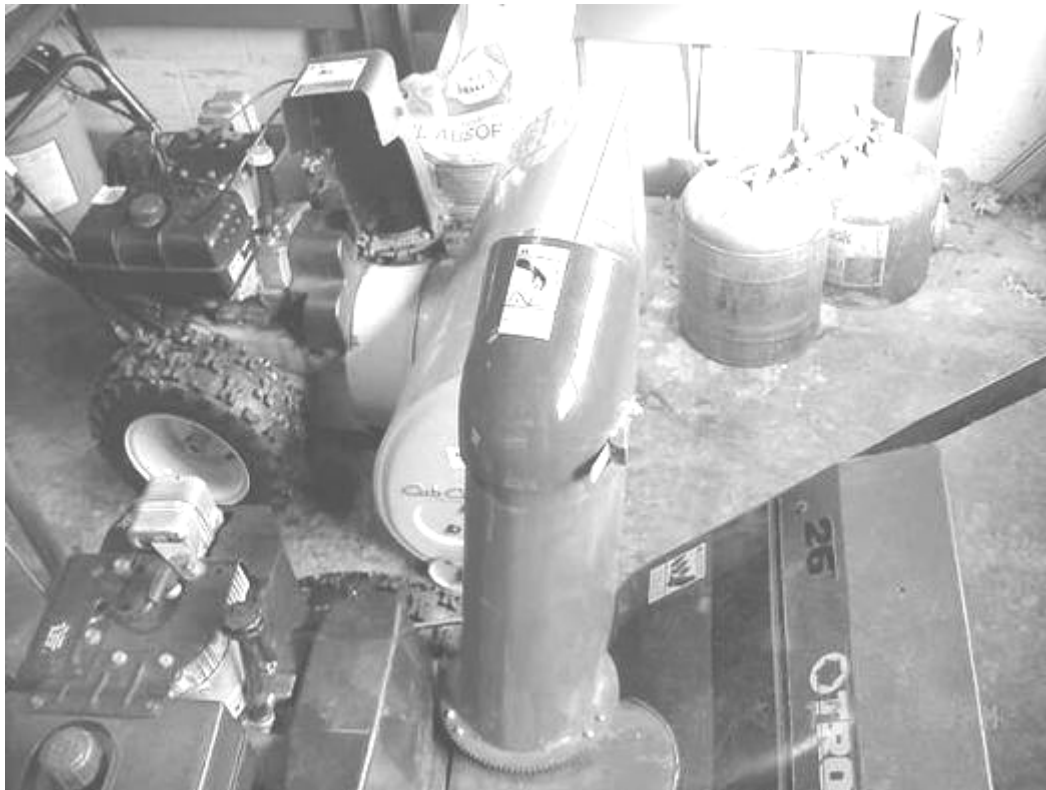
**Picture 19**

Please note, TVOC air measurements are only reflective of the indoor air concentrations present at the time of sampling. A potential source of VOCs was observed in the storage room, which is accessed through a door in the library or through a garage door on the exterior of the building (Picture 18). At the time of the assessment, a gas-powered snow blower, lawn equipment and gasoline containers were being stored inside the storeroom (Picture 19). Odors and off-gassing of VOCs from gasoline can have an adverse effect on indoor air quality. No local exhaust ventilation is installed in this area to remove odors. Several pathways were observed for VOCs and other odors (e.g., combustion emissions) to migrate into occupied areas; these included holes in walls (Picture 20) and spaces around the door to the library. Occupants reported that odors from the gas-powered equipment were periodically detected in the school.

**Snow Removal Equipment and Gasoline Cans in Store Room**

20. Consider storing gas powered snow/lawn equipment and fuel containers in a location outside the building (e.g., storage shed). If not feasible, consult with local fire officials to determine compliance with local/state fire codes

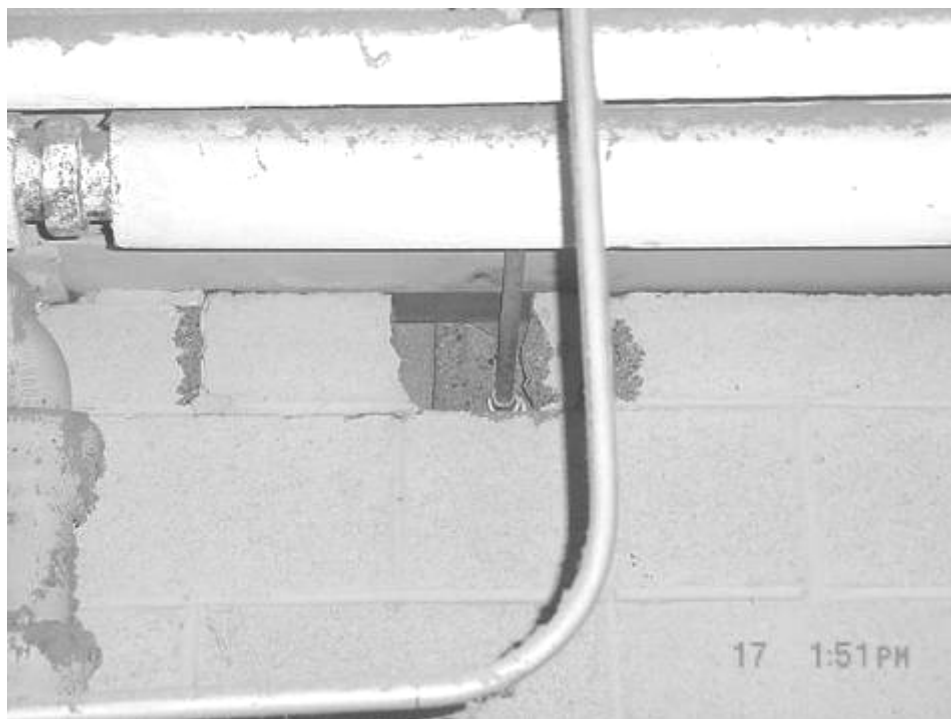
**Picture 20**

**Large Utility Hole in Wall Separating the Library and Storage Room that Contains, the Snow Blower, Lawn Equipment and Gasoline Containers**

21. Seal utility holes/breaches in walls in storeroom to prevent the migration of fuel and/or combustion odors.
22. Consider sealing access door to storeroom in library. If not feasible install weather stripping/door sweeps around exterior doors to prevent, drafts and odor migration. Ensure tightness of doors by monitoring for light penetration and drafts around doorframes.

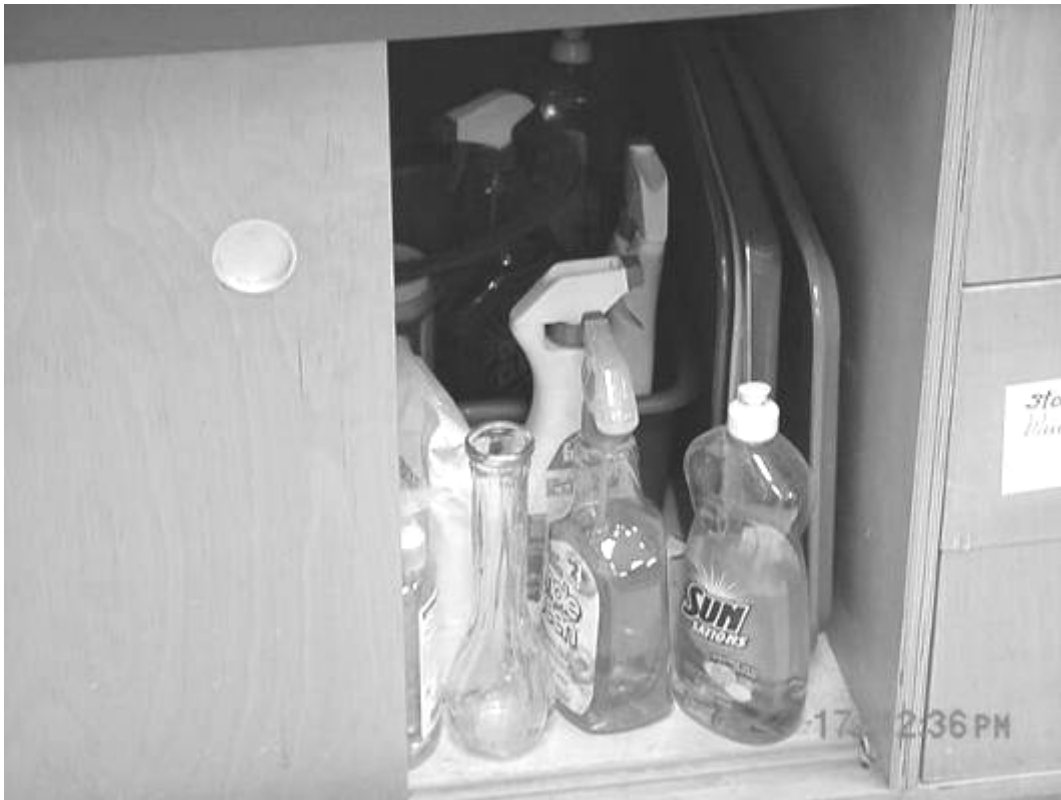
**Picture 21**

**Spray Cleaning Products in Unlocked Cabinet under Classroom Sink**

23. Store cleaning products properly and out of reach of students.
24. Change filters for air-handling equipment (e.g., univents, AHUs and ACs) as per the manufacturer's instructions or more frequently if needed. Vacuum interior of units prior to activation to prevent the aerosolization of dirt, dust and particulates. Ensure filters fit flush in their racks with no spaces in between allowing bypass of unfiltered air into the unit.

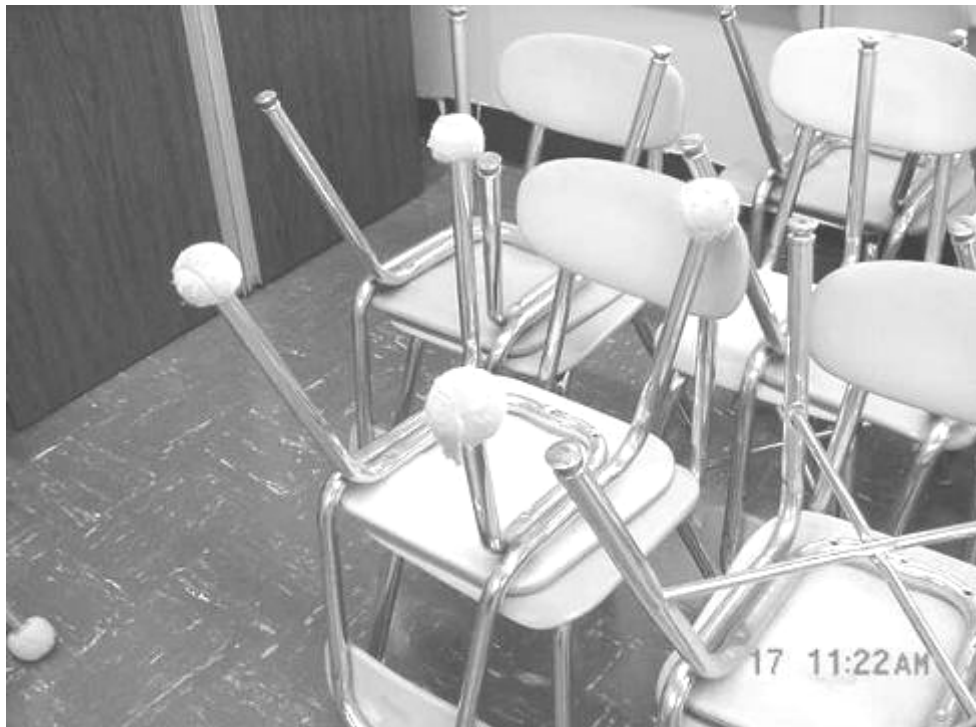
**Picture 22**

In an effort to reduce noise from sliding chairs, tennis balls had been sliced open and placed on chair legs (Picture 22). Tennis balls are made of a number of materials that are a source of respiratory irritants. Constant wearing of tennis balls can produce fibers and cause TVOCs to off-gas. Tennis balls are made with a natural rubber latex bladder, which becomes abraded when used as a chair leg pad. Use of tennis balls in this manner may introduce latex dust into the school environment. Some individuals are highly allergic to latex (e.g., spina bifida patients) (SBAA, 2001). It is recommended that the use of materials containing latex be limited in buildings to reduce the likelihood of symptoms in sensitive individuals (NIOSH, 1997). A question and answer sheet concerning latex allergy is attached as [Appendix B](#) (NIOSH, 1998).

**Tennis Balls on the Bottom of Chair Legs in Classroom**

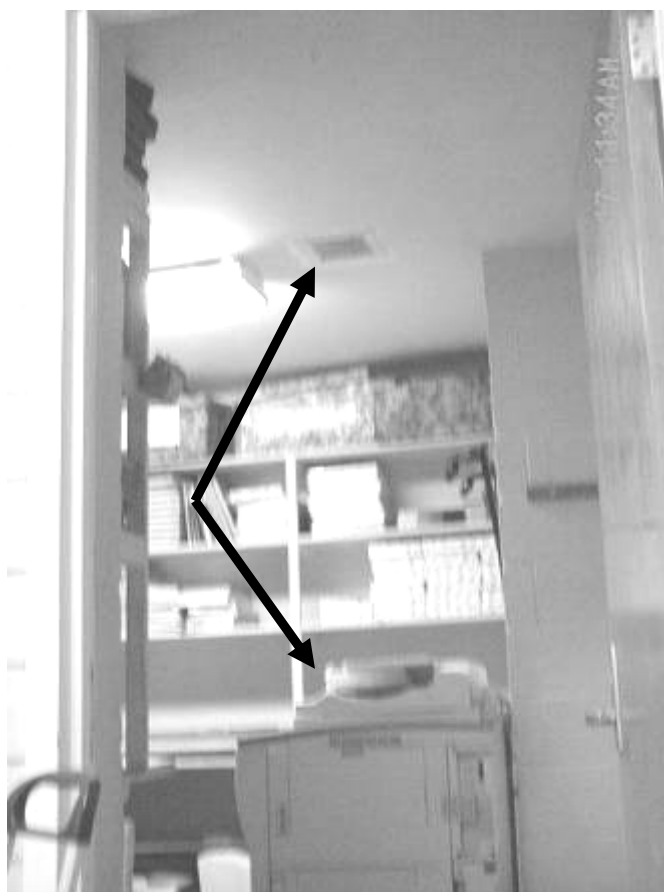
**Picture 23**

A photocopier was observed in the second floor book room. Photocopiers can produce VOCs and ozone, particularly if the equipment is older and in frequent use. VOCs and ozone are respiratory irritants (Schmidt Etkin, 1992). Although the photocopier was located beneath a local exhaust vent (Picture 23), the vent was sealed with cardboard (Picture 24).

**Photocopier beneath Local Exhaust Vent, in 2<sup>nd</sup> Floor Book Room**

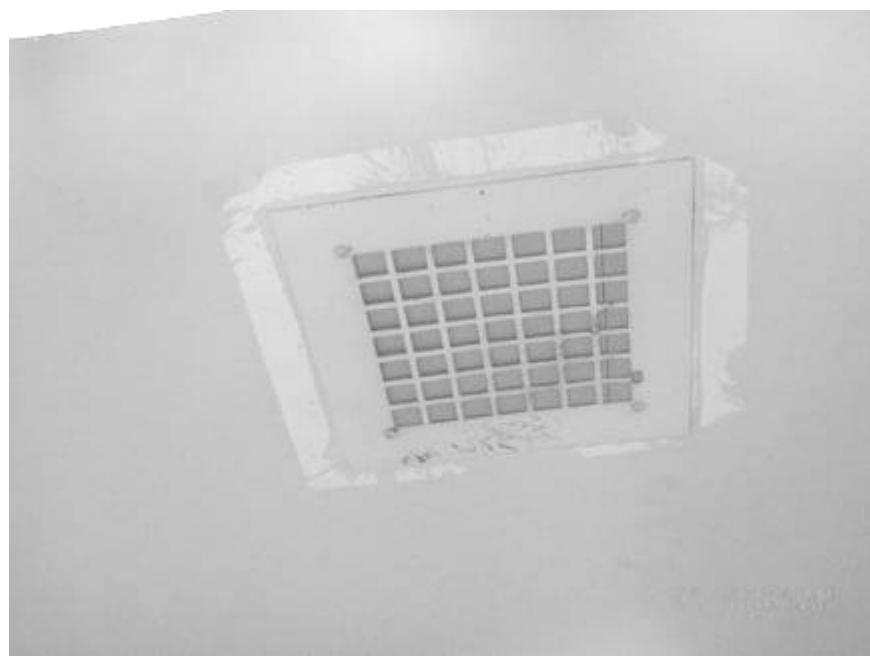
**Picture 24**

**Close-up of Local Exhaust Vent Sealed with Cardboard, in 2<sup>nd</sup> Floor Bookroom**

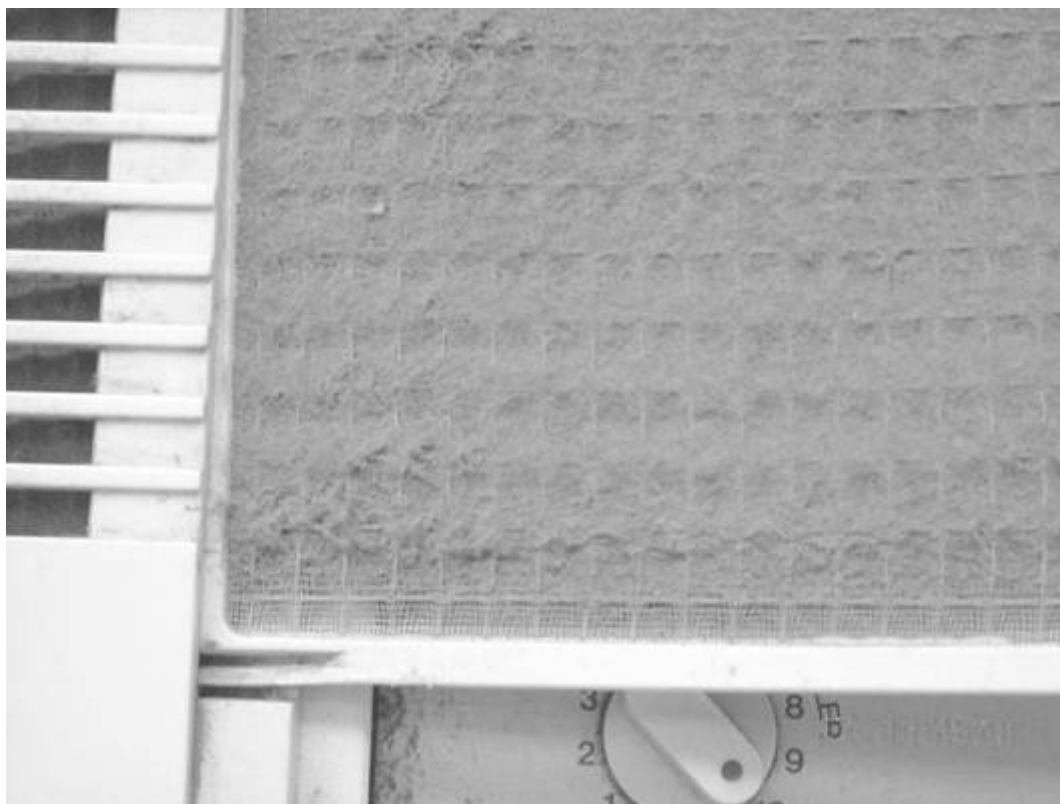
**Picture 25**

**Dust Accumulation on Filter for Classroom Air Conditioning Unit**

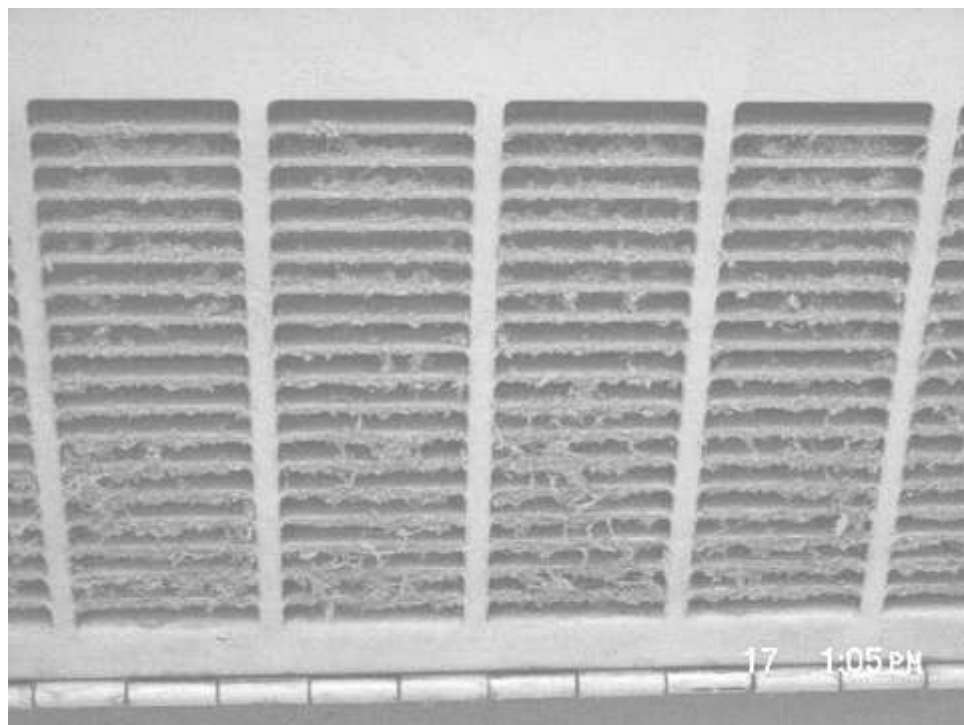
**Picture 26**

**Univent Return Vent**

25. Clean univent air diffusers/return vents, portable air conditioners and exhaust vents periodically of accumulated dust to prevent the accumulation/aerosolization of dirt, dust and particulates.
